TEST REPORT

Custom Mechanical Testing Of JEM10+3 SIDE CHAIR

BUZZ SEATING

Report No. MI-14-7414-3

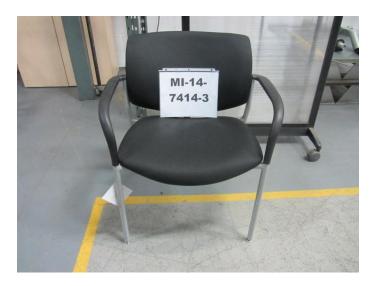
JEM10+3 SIDE CHAIR

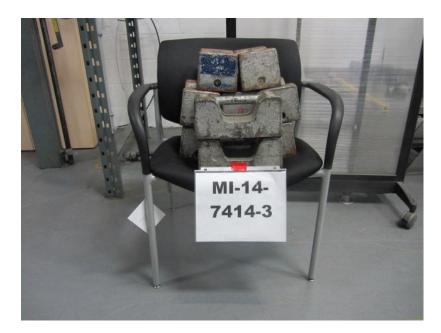
Photograph #1

TEST PERFORMED:Custom static load test of 500 lbs for 24h
(See appended photograph #1)

The chair does not show any structural damage upon load removal

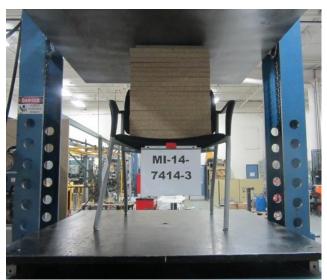
Photograph #3 Chair after peak load reached

TEST PERFORMED: Custom Seat Compression to Failure test (See appended photographs #2-3-4)

The chair started to bend upon 4729 lbf load application
